## Effect of Water Saturation Changes on the Creep and Stability of the Soil Slope Parallel to the Al-Qawasim Mountain Road of North West Libya

The study aims to evaluate the effect of internal water saturation on the stability of the soil slope parallel to Al-Qawasim Road by testing water quantities of 60, 70, and 80 mm and assessing their impact on soil cohesion and friction angle. To achieve this, field observations, laboratory experiments, and numerical simulations using the RocPlan program were conducted. Field data revealed the inclination of tree trunks, indicating ongoing soil creep. Laboratory results showed that increasing the internal saturation ratio from 16.5% to 19.5% led to a significant decrease in cohesion and friction angle, thereby reducing soil resistance. The simulation results confirmed a decrease in the safety factor from 1.002 to 0.3, classifying the slope as being in the "choking stage" that necessitates continuous monitoring and preventive measures.

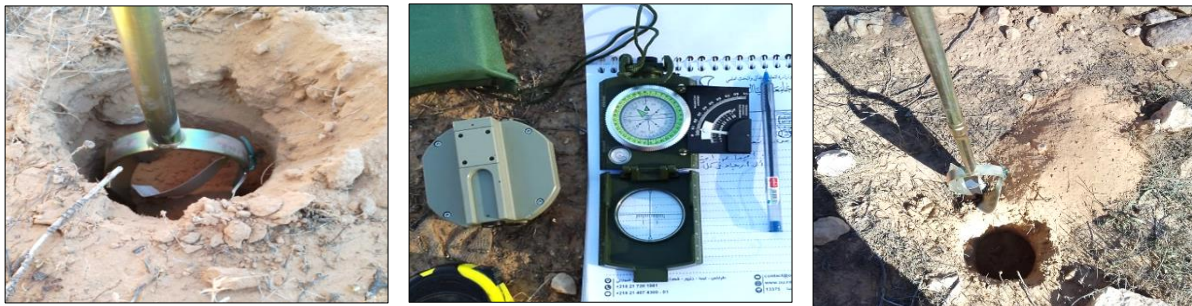
**Figure 3:** Tools used in the field study to collect geological and geometric slope data.

A field visit was conducted to collect essential data through a geological survey of the cut slope parallel to the road. Geological surveys are a fundamental method for gathering field data on slope characteristics.<sup>15</sup> The main data comprised slope geometry, and soil samples were obtained from a depth of 40 cm at the same location cited in reference.<sup>11</sup> The primary tools used during the survey included a geological compass, an inclinometer, and measuring tapes of various lengths Figure 3. Additionally, the interpretive booklet of the Tripoli geological map sheet was consulted for regional context.<sup>16</sup> Table1 presents a summary of the main field data collected. The field observations and measurements collected during this study align closely with the data cited in reference,<sup>11</sup> confirming the consistency of slope conditions at the surveyed location.

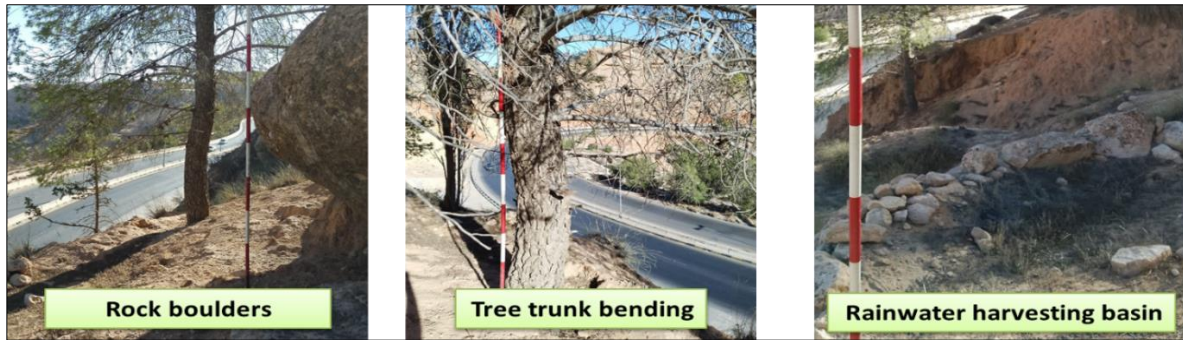
**Figure 8:** Field evidence of human activity and soil erosion affecting the slope

The field study revealed that the soil slope rests on the Kiklah Formation, composed of poorly sorted and chemically weathered sandstone, which forms the slope's base. This base is overlain by a mixed layer of gravel and clay. The slope surface is irregular, featuring drainage channels oriented northwest aligned with the natural slope's average inclination of  $25^\circ$ , while the overall slope orientation is N  $35^\circ$  W. Large boulders were observed on the slope surface, some near the edge of the artificial cut, adding extra pressure to this weakened zone. Human interventions, including tree planting for soil stabilization, were also noted. To irrigate these trees, rainwater collection basins were constructed Figure 8, but these basins allow water to slowly infiltrate the upper and middle slope zones, increasing water saturation. This rise in saturation elevates pore water pressure, reducing soil internal cohesion and friction angle. The Field evidence such as tree trunks bending perpendicular to the cut slope face indicates soil creep directed toward the artificial slope Figure 8, contrary to the natural downslope movement. The curvature of tree trunks on a slope indicates that the soil is slowly moving in a certain direction. Trees adapt to this gradual soil movement by tilting their trunks accordingly. At the same time, tree roots form a strong stabilizing network within the soil, anchoring soil particles and reducing their tendency to slide, which helps slow down or even halt the creeping movement. Therefore, although the curvature of the trunks reflects ongoing soil movement, the presence of trees and their roots plays a crucial role in stabilizing the slope and lowering the risk of collapse. This behavior is to increased water saturation, the weight of boulders Figure 8, and the sharp increase in slope angle from  $25^\circ$  to  $80^\circ$ , due to the cutting process, which weakens the slope's natural structure. These observations align with findings reported by (Alakhdar, 2024).<sup>11</sup>
