The Geologic Contribution to the Mountain Slopes Instability and its effect on Rockfall Hazards. A Case Study to the Zintan Road, Jabal Nafusah, Libya

The paper is intended to address geological characteristics for risk evaluation of rockfall hazards attributable to the high cut in weathered rock that sometimes obstruct the passage of vehicles in the Zintan mountain road case study region and recommend mitigation steps to reduce these threats. The geological structure of the area, the composition of the rocks, the hydrologic conditions, and the steepness of the slopes all affect these materials' strength and susceptibility to failure. The areas at the source of the falling rock have been identified. The evaluation of geological formation and its structures as rocky units of slopes determined in this present study demonstrates that it is mostly comprised of friable rocks interbedded within hard rock such as dolomitic limestone. In addition, it contains a group of fractures and joints, which take different directions, with a slight dipping for the rock layers. Based on field investigation and a detailed study, the weathering and erosion effects of rocks have also been examined in al

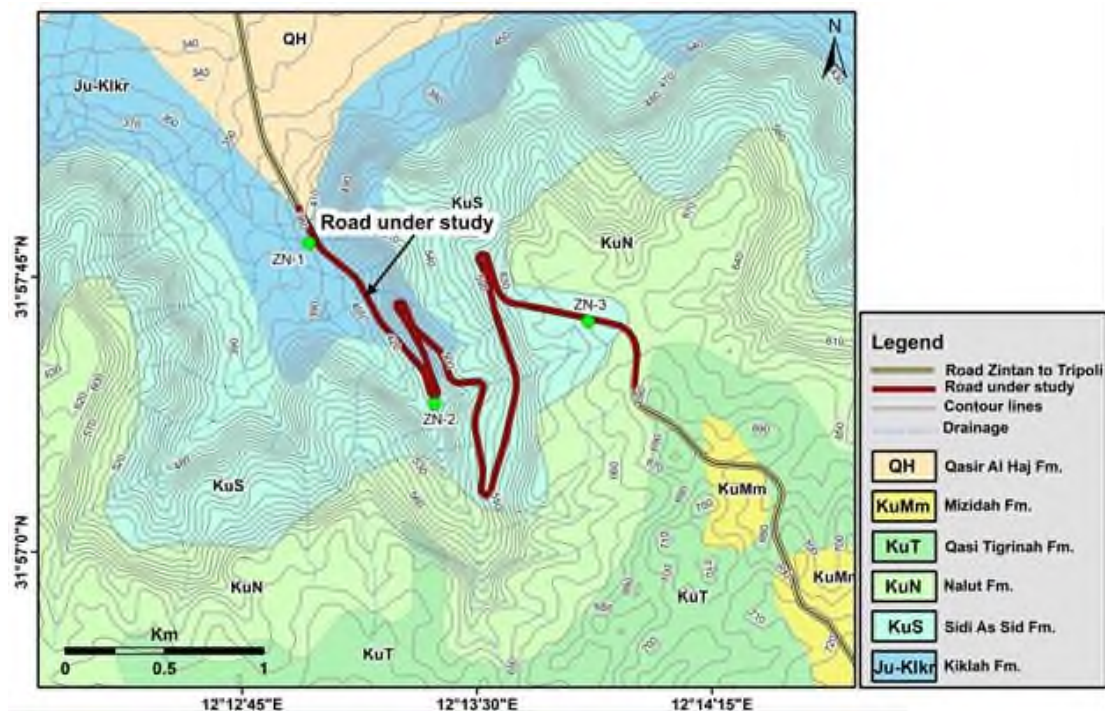
Figure 3 *Geological map of study area as a part of Nafusah mountain region*

From the oldest to the recent are sandstone and clay deposits of kiklah Fm., limestone and marl deposits of Sidi as Sid Fm., and limestone and dolomitic limestone of Nalut Fm., the marl deposits and marly limestone of the Qasi Tigrinah Fm., and deposits of marl, marly limestone, and limestone of Mizidah Fm. In addition to the deposits of proluvial cemented and non-cemented gravels, sand and sandstones with calcareous crust interbed with the Qasir Al Haj Fm.

The study area as a part of this escarpment consists of a number of 6 rock units (Fig. 3 and 4).

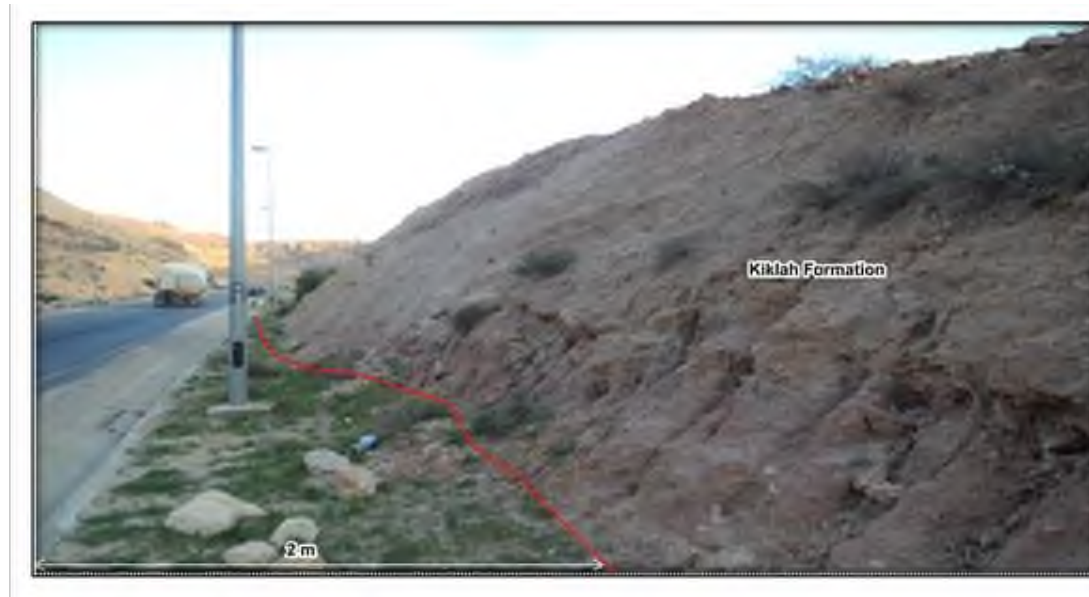
The distance varies between the bottom of the exposed rocks of Kiklah and Ain Tobi Mb. Of Sidi as Sid formations along with the twisted road range from less than one to two meters, and part of these distances are covered with rockfall while the other part

Photograph 2. Shows the distance between the exposed rocks units and the road footnote.

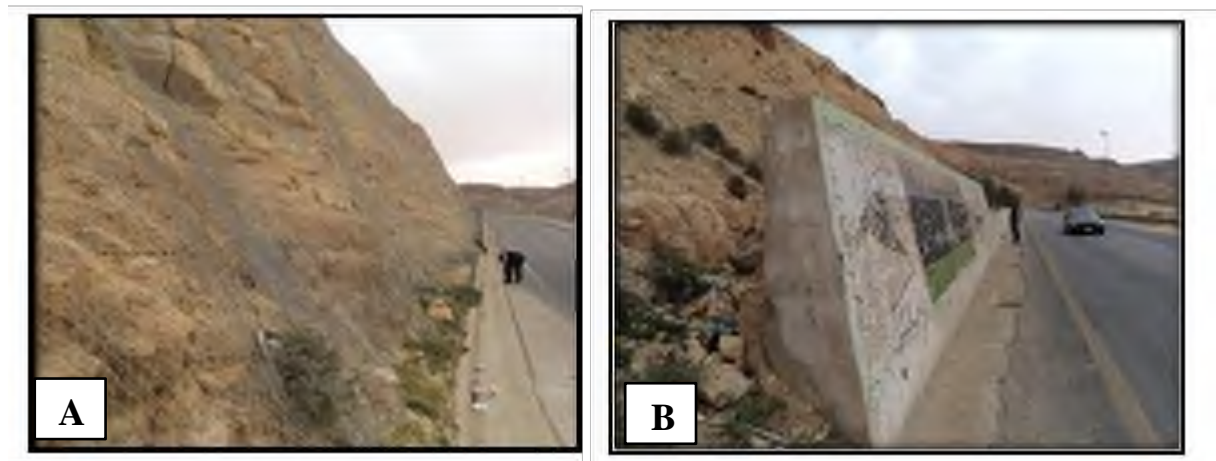
This road which is in the form of a zigzag starting from the Zart Valley is characterized by the presence of concrete walls, lamellar metal walls (photograph 3A-B,) and metal grids created to reduce the fall of those rocks that were created on the edge of the road to prevent the rockfall. The rocks of these formations are highly affected by weathering factors such as wind and rain, which contribute greatly to the closure of the road as a result of the rockfall of this formation, which led to the creation of laminar metal walls to reduce the risk of rockfall and landslide.

Photograph 3 (A - B). Showing the use of metal nets fences and concrete walls to prevent the rockfalls of Ain Tobi Member.

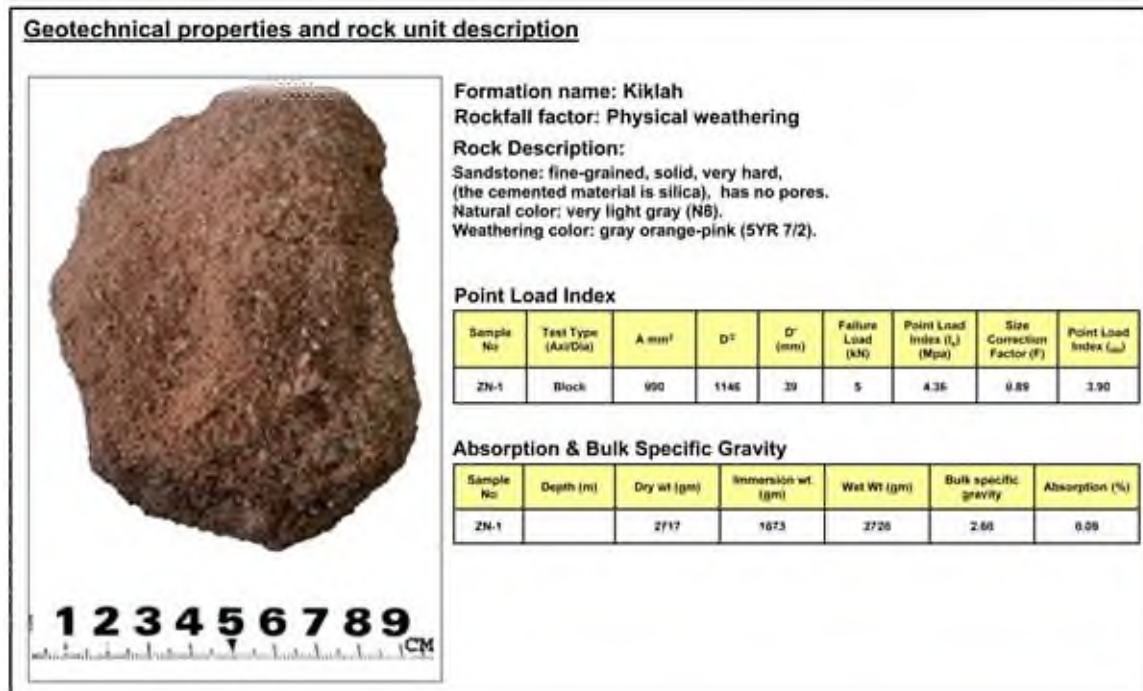
Figure 5 Geotechnical properties and rock unit description of the rock sample (ZN-1) of Kiklah Formation

fractures due to the freezing and increase of water volume. Laboratory results of Kiklah Formation showed that these rocks have very little ability to absorb water by 0.09% (Figure 5) whereas for Ain Tobi Mb. of Sidi as Sid Formation was 1.67% (Figure 6) and Yafram Marl was 1.98% (Figure 7).

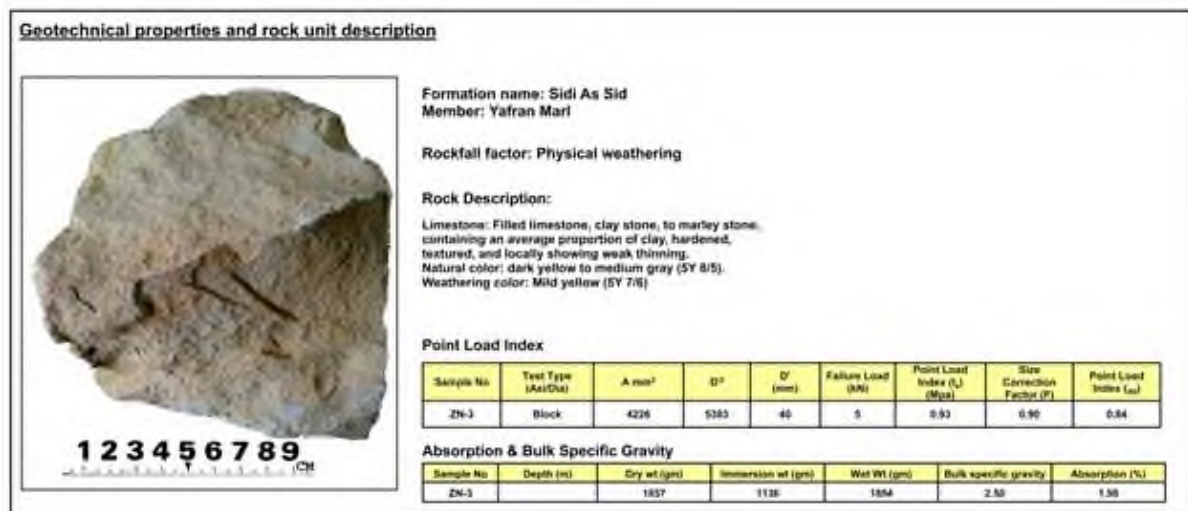
Figure 7 Geotechnical properties and rock unit description of the rock sample (ZN-3) of the Yafran Marl Mb. of the Sidi as Sid Formation.

Regarding Yafran Marl Member of Sid as Sid Formation rocks which lie on top of Ain Tobi Mb., they are relatively far from both sides of the road and appear in one of the quarries, as they do not contribute in any way to the closure of the road due to the rockfall. Laboratory results showed that these rocks have the ability to absorb water at a very small rate of 1.98% (Figure 7).

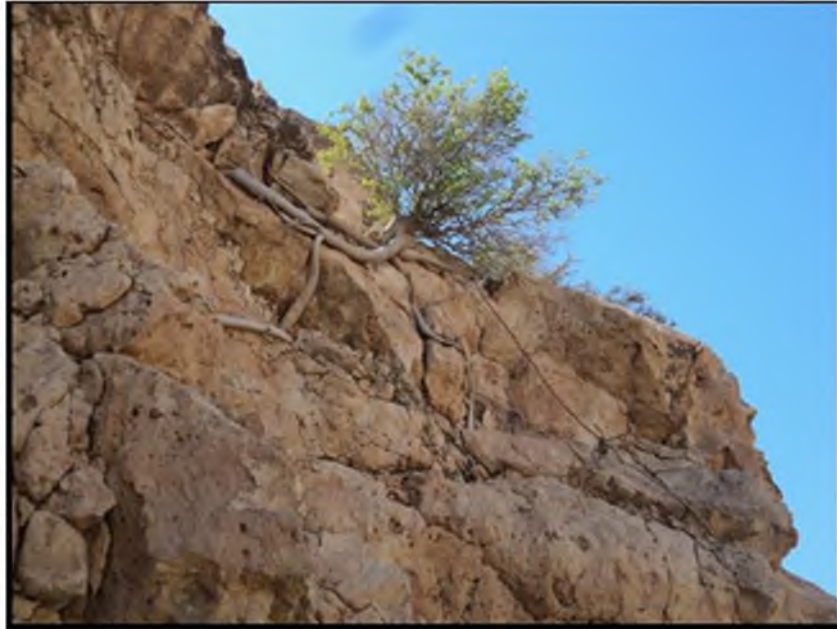
Also, the mountainous facades and their slope affected by the wet season rains, despite their scarcity, resulted in weakness and loosening of the clay rocks, thus removing them, which caused the rocks to slip. As for the biological factors, their effect is very clear, as the nature of this type of rock and its contents include clay and sand helped the growth of some small and large herbal trees, especially inside fractures and fissures (Photo 4).

Photograph 4. *Illustrates grow of some trees especially inside the fractures and fissures.*

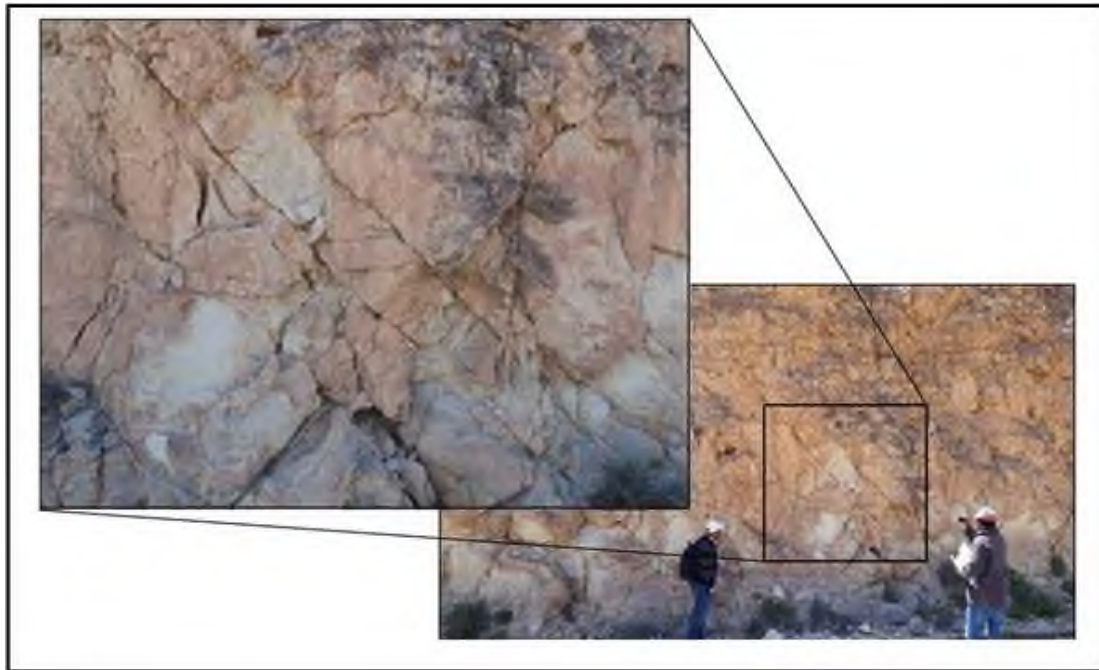
The lithology on both sides of the road is mainly dolomitic limestone, and marl, of Ain Tobi Member, which is cut by several sets of joints to form blocks, wedges, and other geometric forms that are likely to move downward from the parent rocks in the form of rockfall.

limestone and mudstone areas and the risk of rockfall and landslides is increased by the presence of some orthogonal fractures, especially in the Free Faces.

Photograph 5. *Illustrates the abundance of fracture and joints in Ain Tobi Member that helped break rocks and fall (People for scale).*

4. Use metal screws to fix parts of the rock that are expected to collapse.
5. Reduce the slope angle and minimize the stresses which affect the slope.
6. Working on graduating the slopes of large or high slopes as agricultural terraces.
