## Highlights on the phenomena of Sbeia ground collapse, preliminary diagnosis from field observations

Ground cracks and collapse occurred recently in Awlad Abu Aisha area, municipality of Sbeia, is a serious event as it is unexpectedly caused abnormally extensive damage to the ground. In general, ground cracking is regarded as a natural phenomenon that are usually derived by seasonal temperature fluctuations acted on recent sediments dominated by mud; muddy soil. Such soil owns property preferable for shrinkage cracks to occur. The affected site is a low-populated agricultural region with no heavy building nor industrial activities. While the habitually known ground cracks are small and not dangerous, these ones, called Sbeia cracks, appear to have been unusually rapidly enlarged. They become a source of wariness to the local inhabitants who considered these cracks as a mysterious phenomenon. Apart from the public opinions about the secret behind these cracks, there is no any published research devoted to their origin. This is prompted us to visit/revisit the site of ground damage intending to investigate all aspects and appearances related to the Sbeia cracks. Consequently, the

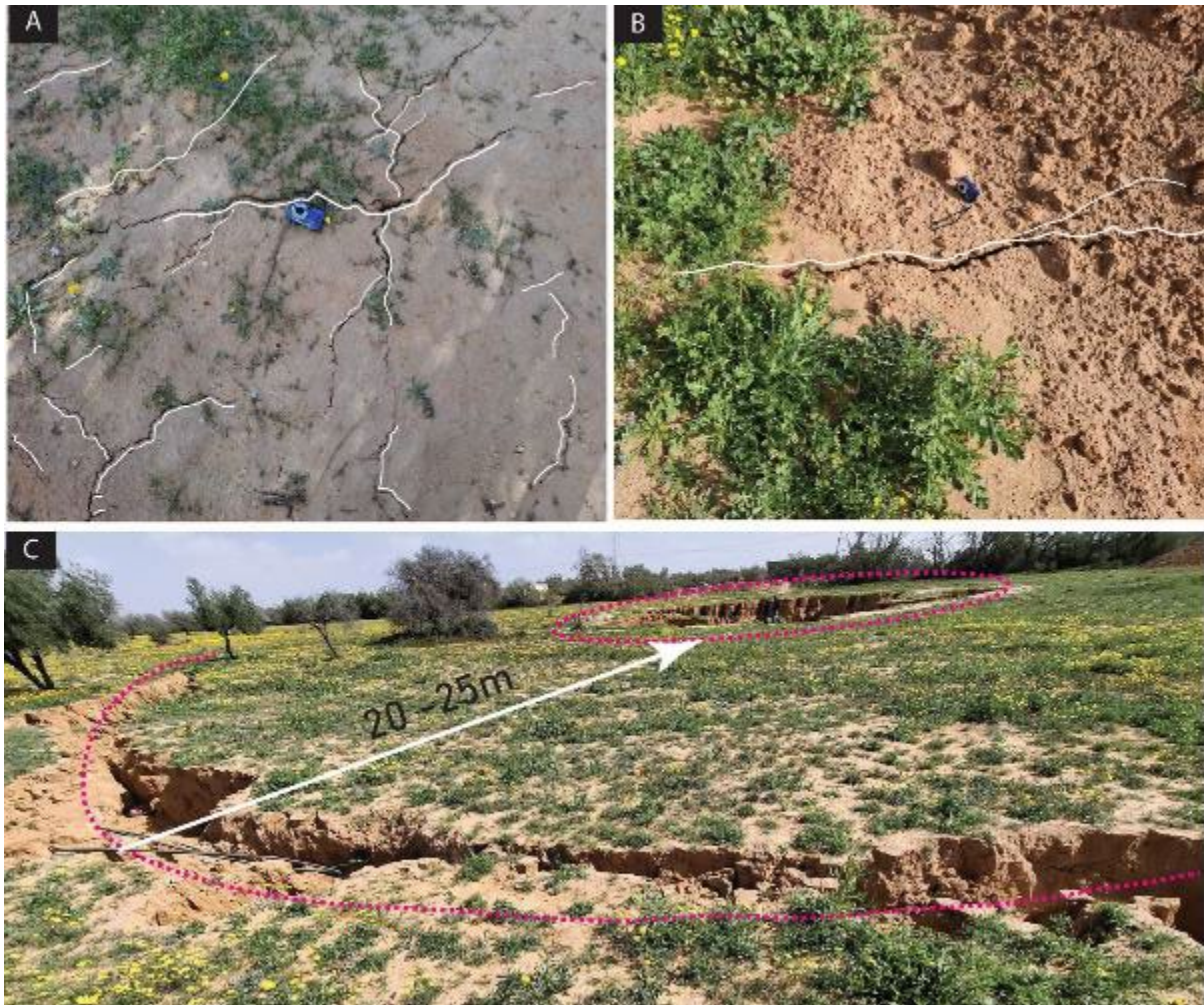
**Figure 3.** The cracks morphology and size: A) the commonest pattern taken by the small cracks (usually at a distance from large cracks (camera for scale); B) elongated cracks usually attached to larger crack; C) large; several tens of meters semicircular cracks (dashed line) centered around the deepest collapse. Subtle inclination of the ground can be noted from the crack toward the collapsed spot (dashed circle).

The cracks/collapse morphofeatures and the properties of the cracked soil are the two directly visible components that define this phenomenon. The cracks are of variable size, morphology and are of semicircular trends (Fig. 3). Their sizes are as large as several tens of decametres and as small as few centimeters (Fig. 3A) in length. In width they range from few millimetres to a few meters. Their depths are up to 2m in average, the depth proportionally increases with the length. Exceptionally, the depth measures more than 5m or more at the collapsed (trench-like) hole (Fig. 3C and 4A, B) . The overall appearance of the centimetre-sized cracks is polygonal

(Fig. 3A), radiating and random networks also seen. These small cracks are commonly occurred in-between, around, and connected to the large ones.

Contrastingly, the large cracks are generally subcircular at its long axis and V or U shaped in vertical view. It is obvious, in plain view, that these subcircular cracks are centered curvilinearly around the deep collapse (Fig. 3C and 4C). What should not be ignored here is the presence of a slight downward slope towards the deep (trench) collapse. Worth mentioning also that the larger cracks are exhibiting recent marks of water pathways at their bottom, these are presented as small ditches and channels (Fig.4A). A local widening of the cracks is also observed on their sides, indicating water erosion. In this regard, farmers have noted that rainwater seeps into the cracks and, unusually, infiltrates rapidly into the subsoil. Regarding the deep collapse ( $> 5\text{m}$ ; Fig. 4A and B), this collapse appears as irregularly circular trench goes rapidly from 0 to  $>5\text{m}$  and it measures about 15 m average diameter. The curved semi-circular cracks encircling this collapsed area is nearly 90m long, having a width of up to 2m (Fig. 3C).

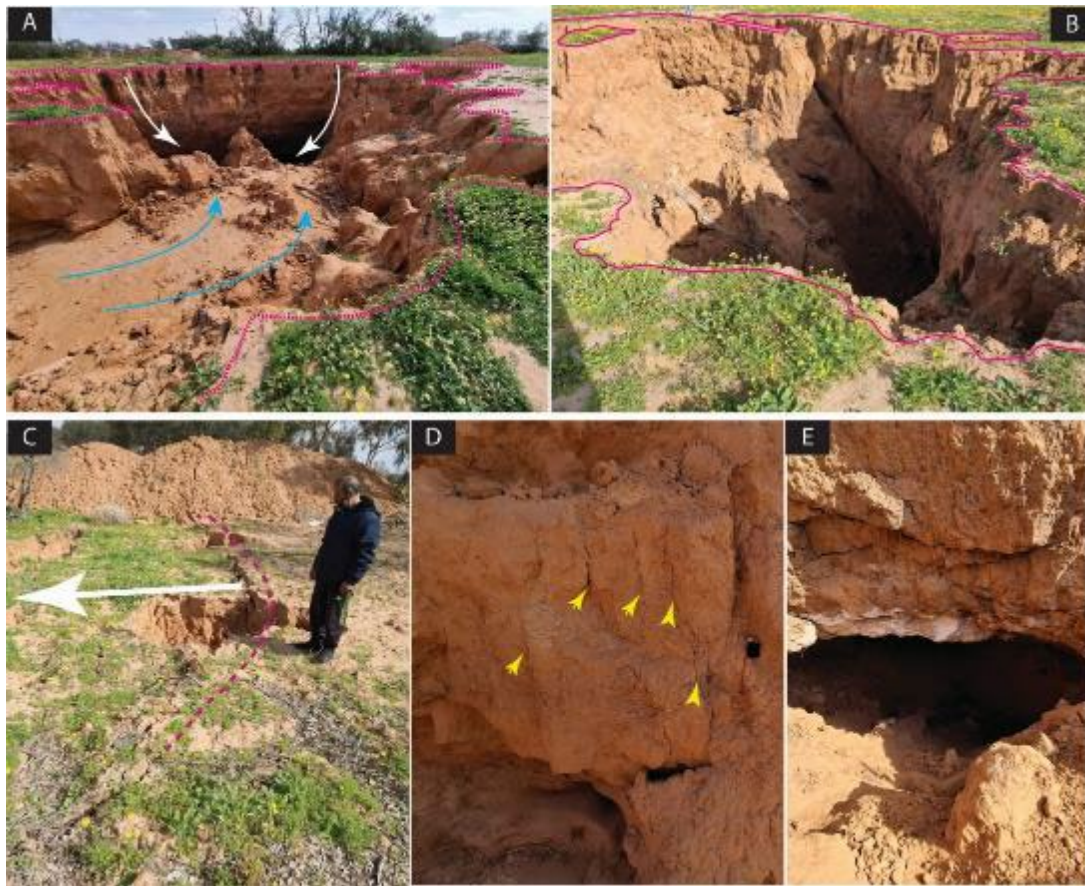
**Figure 4.** Characters of the large cracks and collapses: A) subsided soil with >5m trench-like hole (white arrows); the blue arrow tracks the pathway towards the sunk ground; B) closer view of the sunk ground; C) subcircular crack (dashed line) centered around subsided ground, a repeated feature; D) cross-section from the upper part of the trench shows the surface soil interval. The columnar structure here witnesses for clayey soil type, the arrows points to the (open) joints that limits the soil columns; E) shows the middle soil interval represented by the white and hard caliche horizon. An empty cave is obvious below the caliche which acts as a bridge supported by the subsoil.

Very clear and representative soil section is exposed by the trench (Fig. 4). Visible physical differences in this section suggests its subnivium into three superimposed intervals.: Two thick intervals of fine-grained cohesive soil separated (intermittently) by relatively too thin and too hard caliche bed. The three intervals of the soil section are described hereunder in descending order:

(i) The surface soil, is 1.5 to 2m thick extends from the ground surface to the top of the caliche (Fig. 4D and E), or to the top of lower soil when the caliche is absent (Fig. 5B). The grain size of this soil ranges from fine sand to clay, the clay fraction is estimated at 30%. Its color is light brown. This interval locks homogeneous and is weakly indurated (standing cross section), weak plasticity (could be crumbled by hand). Columnar structure is obvious characteristic of this soil with vertical joints delineating adjacent columns, the joints are millimetric in width (Fig. 4D). Recent roots exist in this layer; roots are denser and deeply penetrating close to (olive) trees. finally, the surface soil interval ends down at interval (ii), the caliche bed. This bed is 0.1 to 0.3m thickness, clearly distinguished by its contrastable hardness and white color (Figs. 4E, 5A). Strictly speaking, this hard caliche is discontinuous and is broken at the collapsed zone. What is especially interesting, is the presence of wide cavity below this hard caliche. The caliche in this case appears like a bridge anchored by the lower soil interval (Figs. 4E, 5A,).

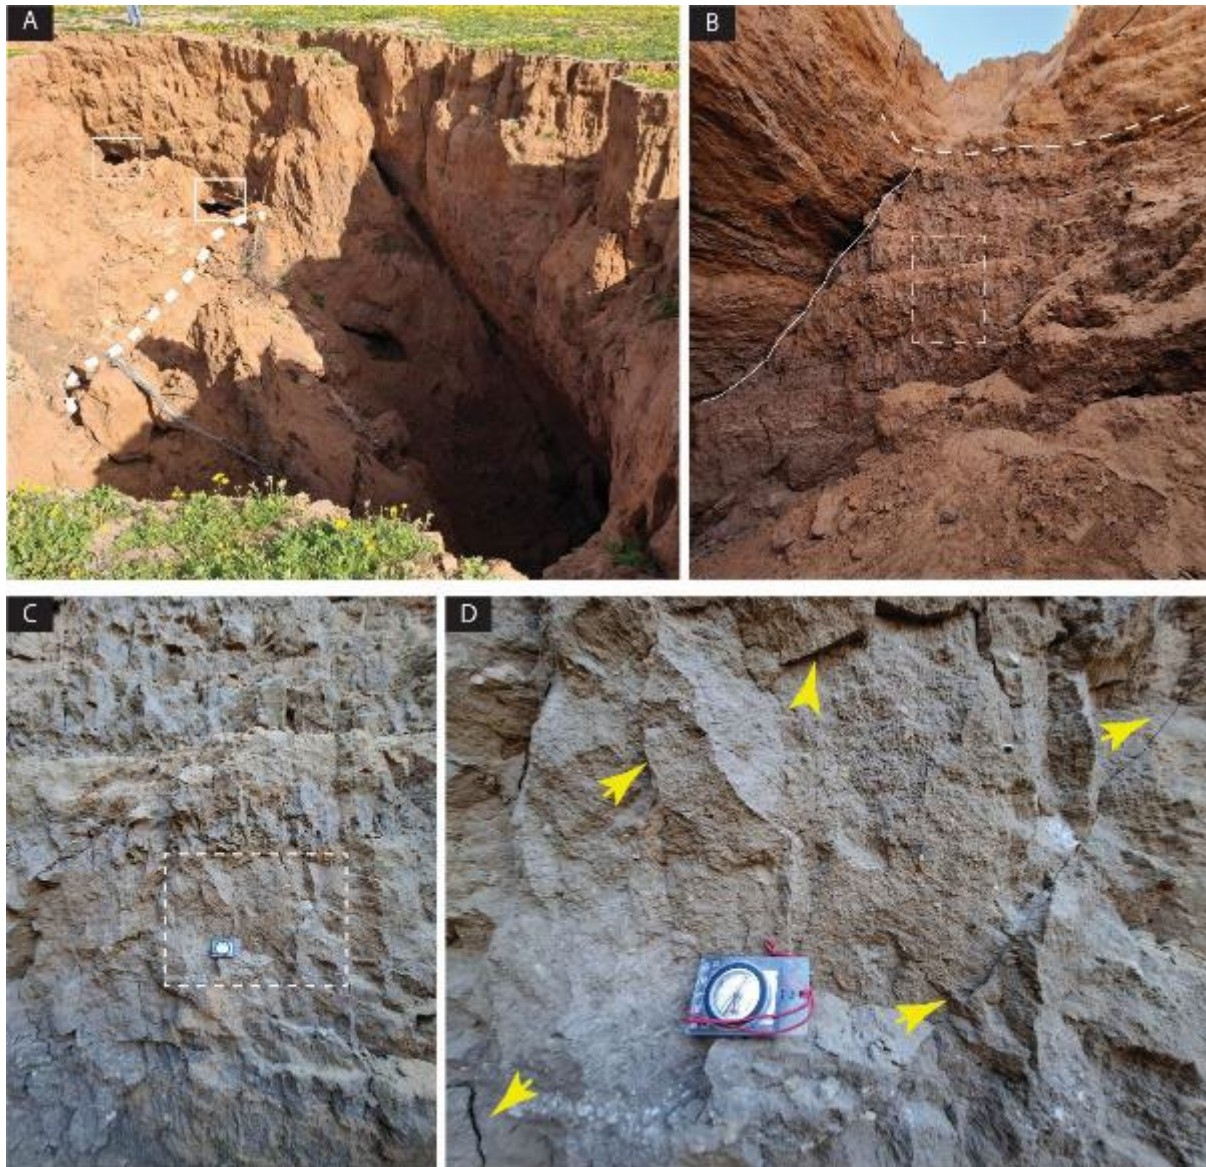
**Figure 5.** Visible characteristics of the exposed soil section: A) the trench made by the collapsed soil, it shows the position of the caliche (marked by the dashed line) and the erosion cavity below the caliche (the rectangles); B) representative view of the soil section, the dashed line separates the upper soil from the subsoil, the inclined line traces a large fracture in subsoil, the dashed rectangle is a view in the subsoil magnified in C) which shows the heterogeneity within the subsoil, represented by the presences of sandy patches/layers within the clay-dominated grey soil; D) close view from ( the rectangle in C) shows that the subsoil is intensely fractures, the arrows points to open fractures and fracture faces

(iii) the lower interval is at least 3m thick (Fig. 5). Unlike the surface soil, this one is clay-dominated. It appears in the form of stratified and compacted layers of hardened mud containing small intercalations of very fine sand. (Fig. 5C). The sand is also as small irregular buckets within the mud. Gray and greenish gray is the dominating color of this interval, light brown for the sandy layers and buckets. Remarkably, this soil is fractured. Joints are 1-2 mm wide, irregularly oriented and are several cm in length. Exposed fracture faces are wedge- and bowl-shaped; a character that is certainly belongs to clayey soil [19] (for further explanation). Streaks of descending water are clearly visible on the faces of some fractures.
